ORNL/RASA-92/14

**Results of the Radiological Survey at  
the former Alba Craft Laboratory Site  
Properties, Oxford, Ohio  
(OXO001)**

**HEALTH AND SAFETY RESEARCH DIVISION**

**Date Issued - March 1993**

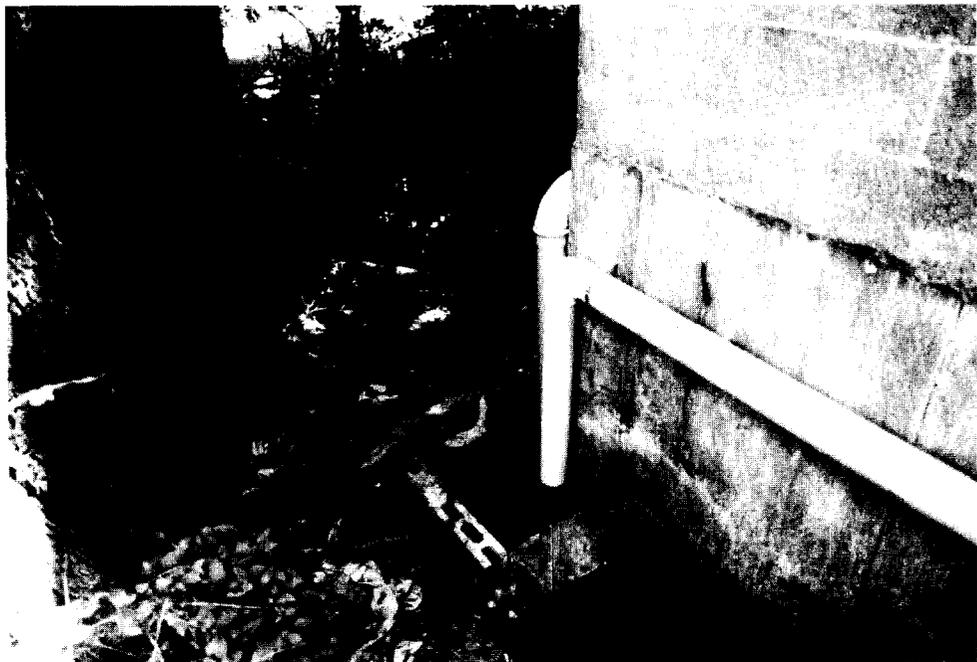
ORNL-PHOTO 1410-93

concentrations at or above DOE guidelines used at other sites (Table 1). Samples B3C, B4, B5, B8B, B10, B13B, and B20B-C showed  $^{238}\text{U}$  values at or below DOE guidelines used at other sites (Table 1). Sample B22 was taken from a storm drain on property directly east of the storm drain at the northeast corner of the building.

Fig. 10. View of northeast corner of building showing roof drains, drainage pit, and location of sample B21.

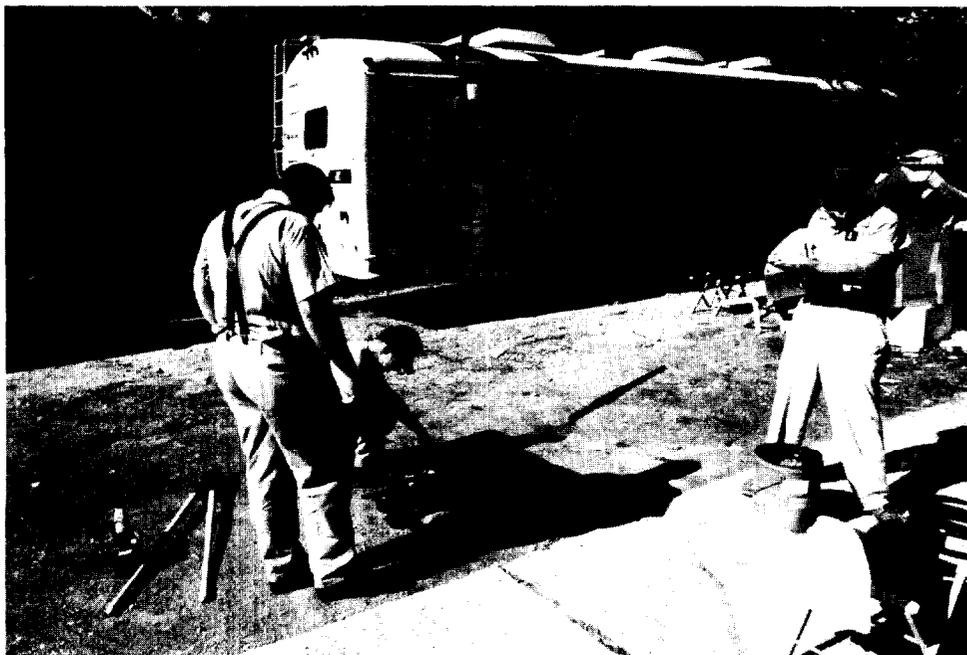
Samples taken at locations B4 and B5 were collected to establish a pattern based on elevated readings at locations B2 and B3. The measured pattern of contamination was different than expected because of excavation to install a water line for a city fire hydrant about 15 feet due west.

Fig. 11. Sampling of contaminated soil adjacent to concrete pad at south end of building (samples B1-B3).

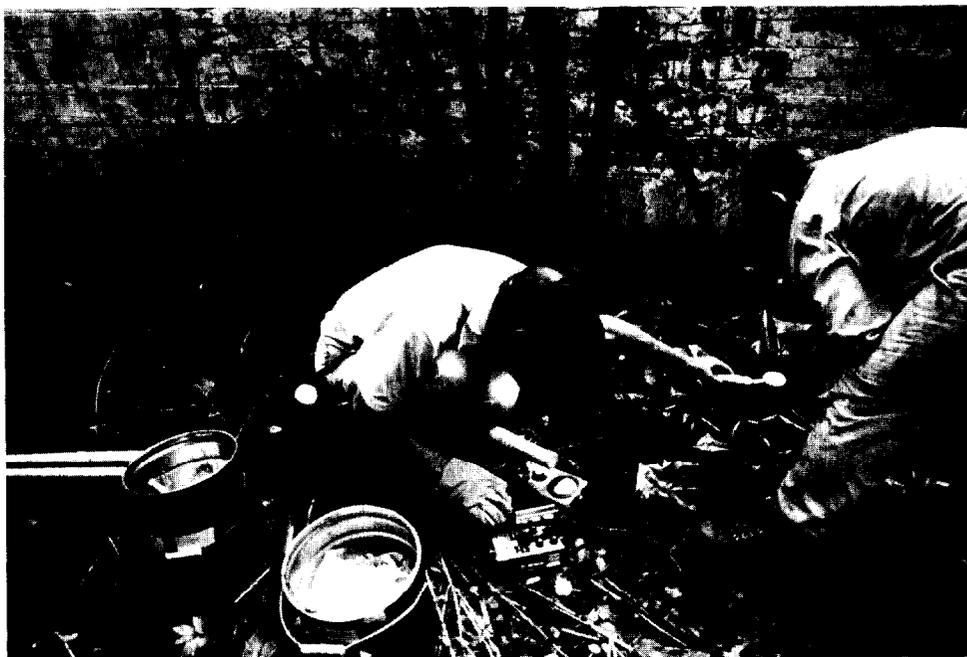
Fig. 12. Sampling of contaminated soil on west side of building (sample B7).
